EMC TEST REPORT

Document No.: 29050AA

**ACCELERATION SENSOR
AIS 3520LN-010**

Advanced International Sensors GmbH

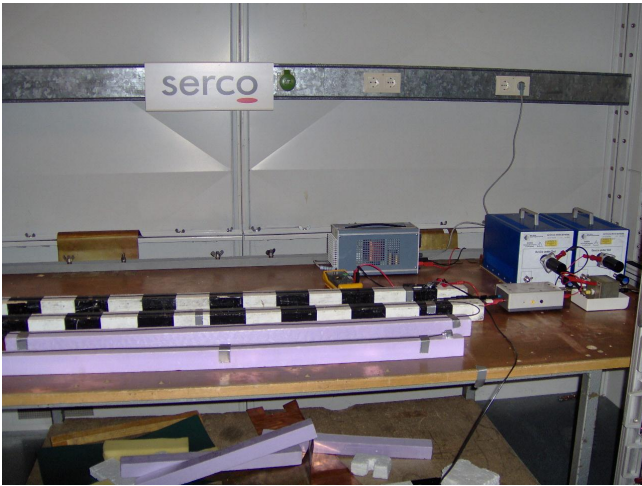
Photo 10.1

| Photo | Description |
|---|---|
| 10.1 | EUT Set Up on Ground Plane and routing of cable harness |

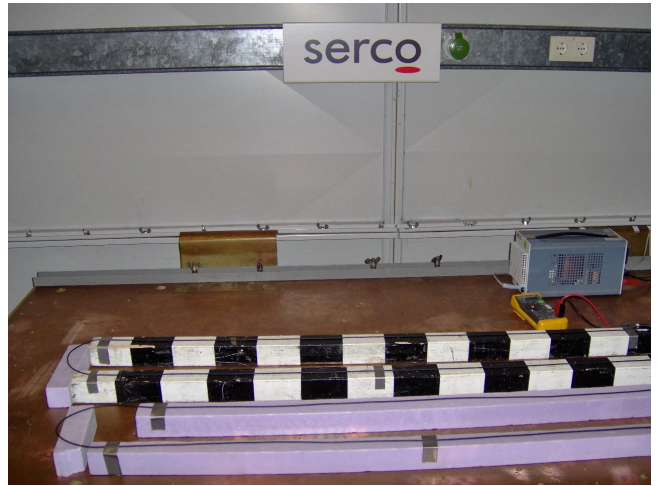
Photo 10.2

| Photo | Description |
|---|---|
| 10.2 | EUT Set Up on Ground Plane and routing of cable harness |

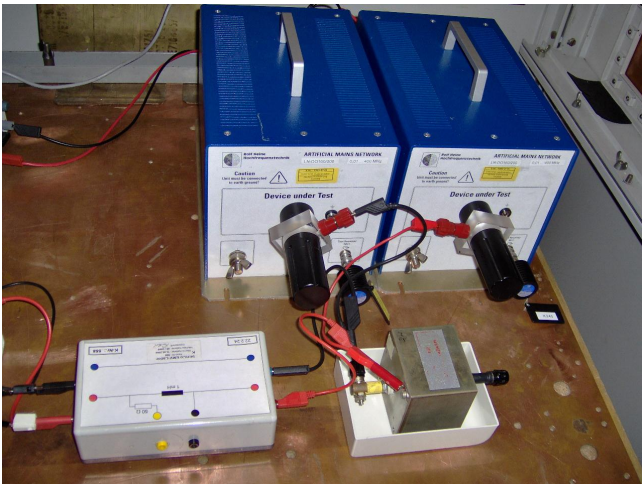
Photo 10.3

| Photo | Description |
|---|---|
| 10.3 | Decoupling capacitor |

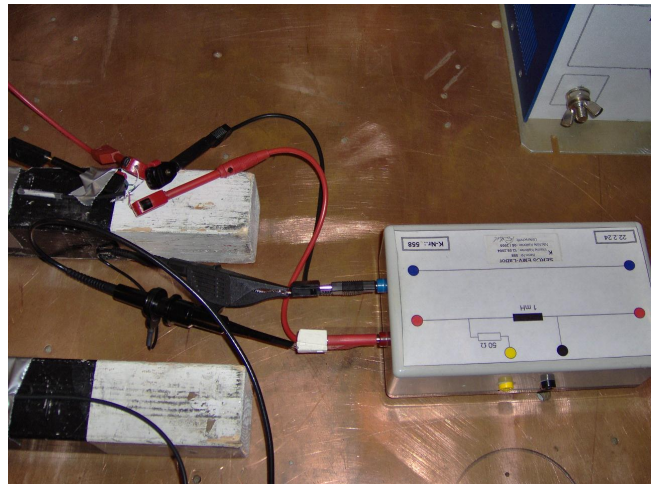
Photo 10.4

| Photo | Description |
|---|---|
| 10.4 | Coupling Network |

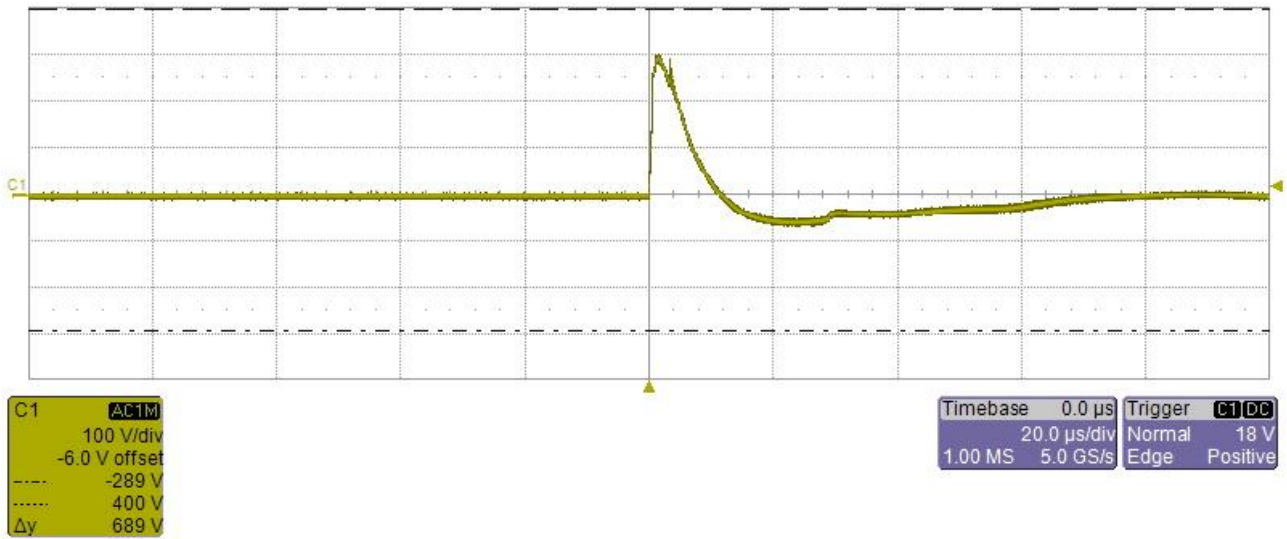
Diagram 11.1

| Photo | Diagram | Remark | Test Result |
|---|---|---|---|
| - | 11.1 | Calibration, +300V | n.a. |

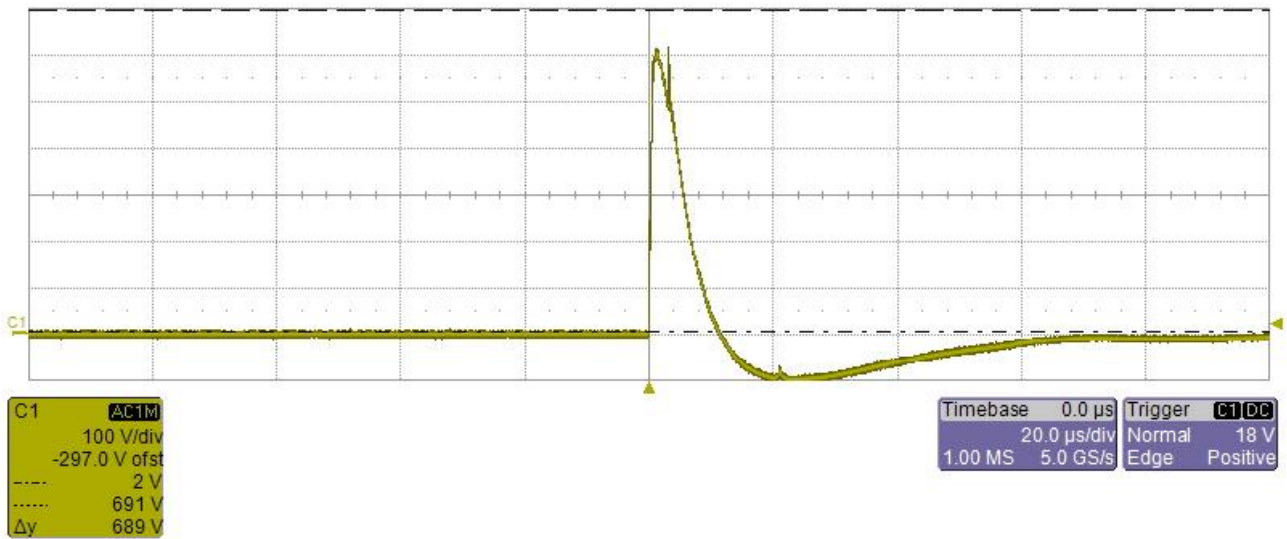
Diagram 11.2

| Photo | Diagram | Remark | Test Result |
|---|---|---|---|
| - | 11.2 | Calibration, +600 V | n.a. |

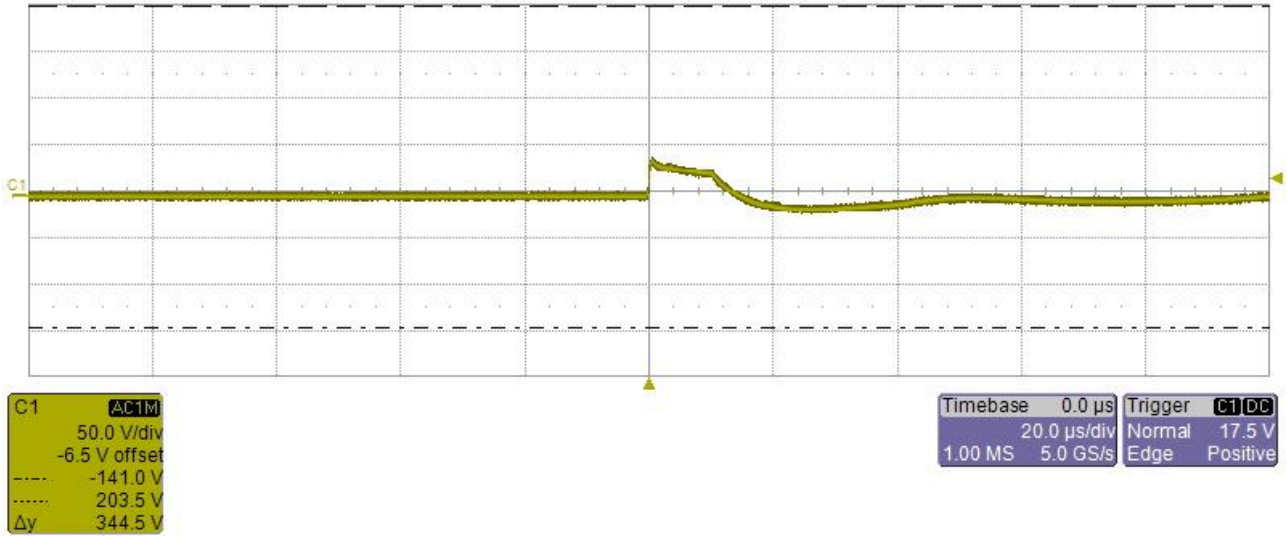
Diagram 11.3

| Photo | Diagram | Remark | Test Result |
|---|---|---|---|
| - | 11.3 | Measurement +100 V | pass |

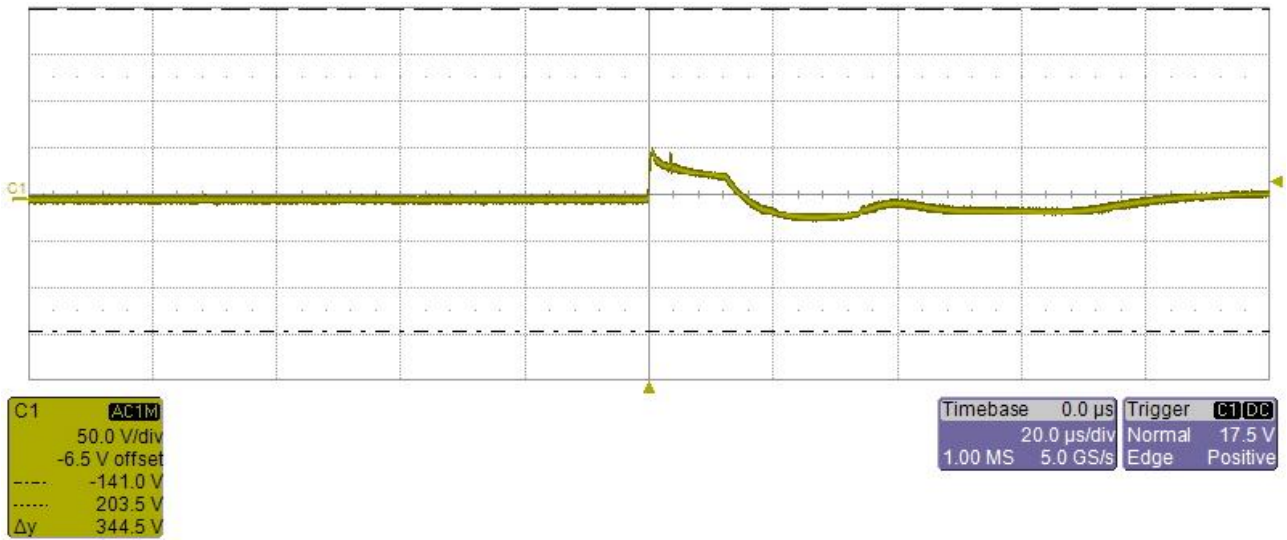
Diagram 11.4

| Photo | Diagram | Remark | Test Result |
|---|---|---|---|
| - | 11.4 | Measurement +200 V | pass |

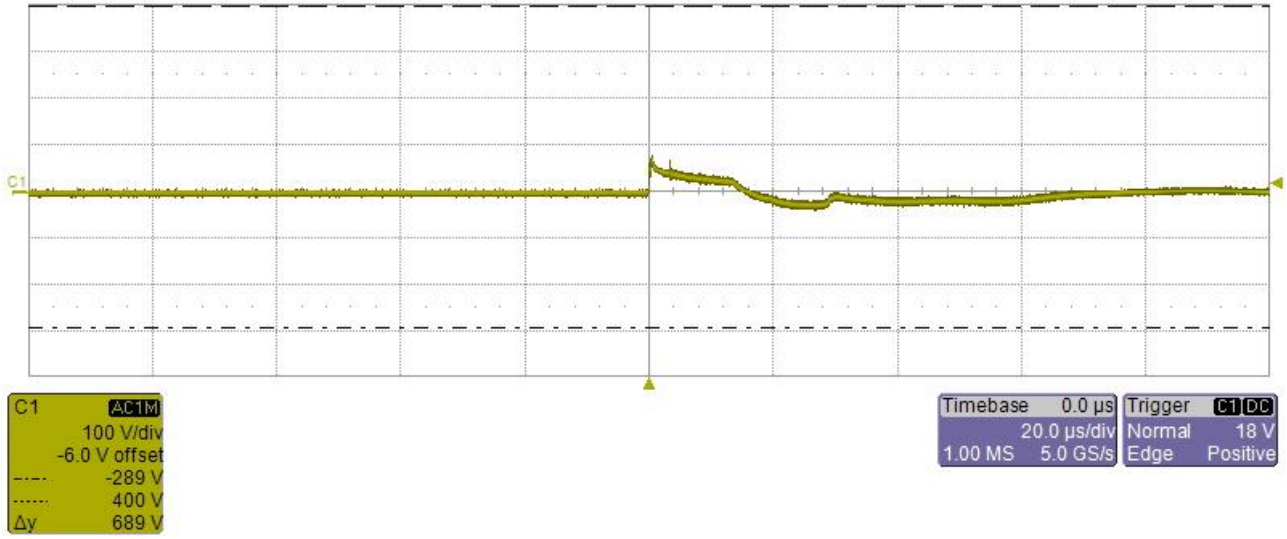
Diagram 11.5

| Photo | Diagram | Remark | Test Result |
|---|---|---|---|
| - | 11.5 | Measurement +300 V | pass |

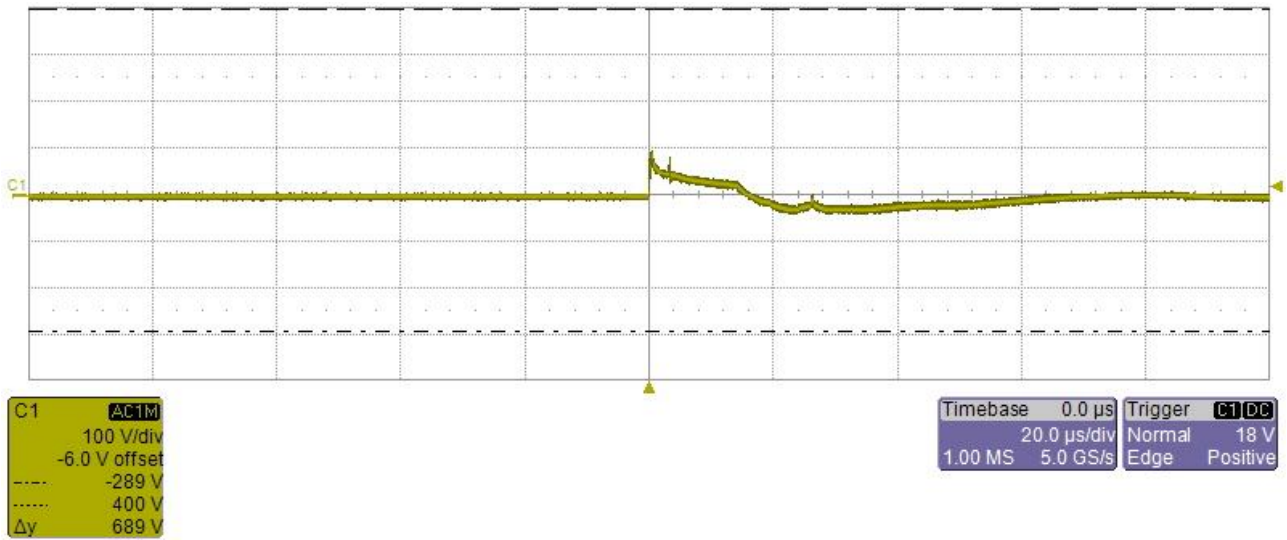
Diagram 11.6

| Photo | Diagram | Remark | Test Result |
|---|---|---|---|
| - | 11.6 | Measurement +400 V | pass |

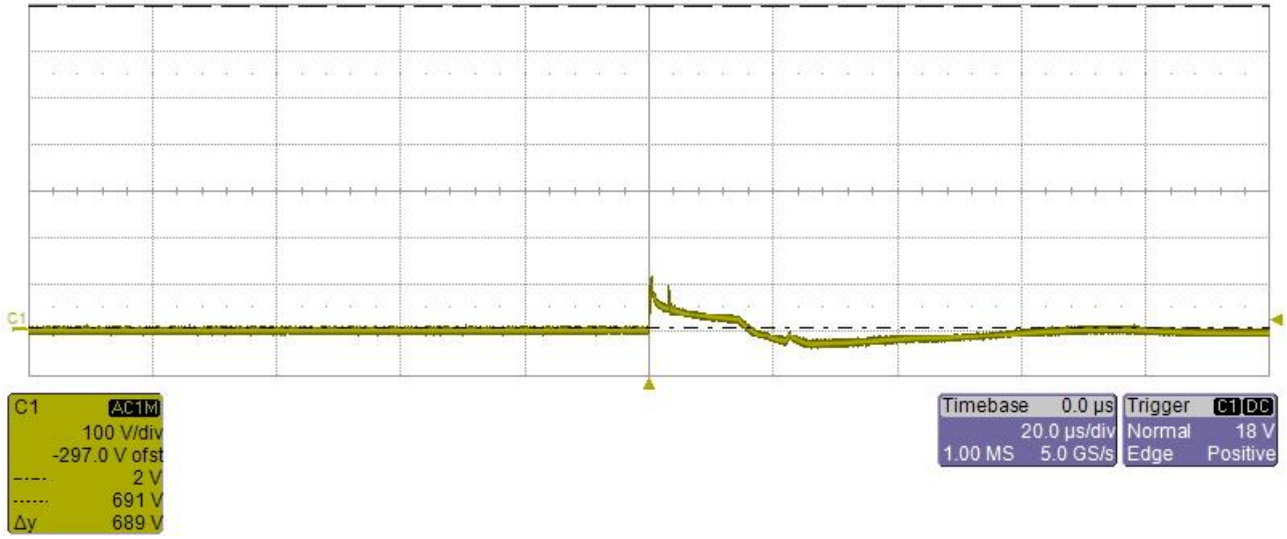
Diagram 11.7

| Photo | Diagram | Remark | Test Result |
|---|---|---|---|
| - | 11.7 | Measurement +500 V | pass |

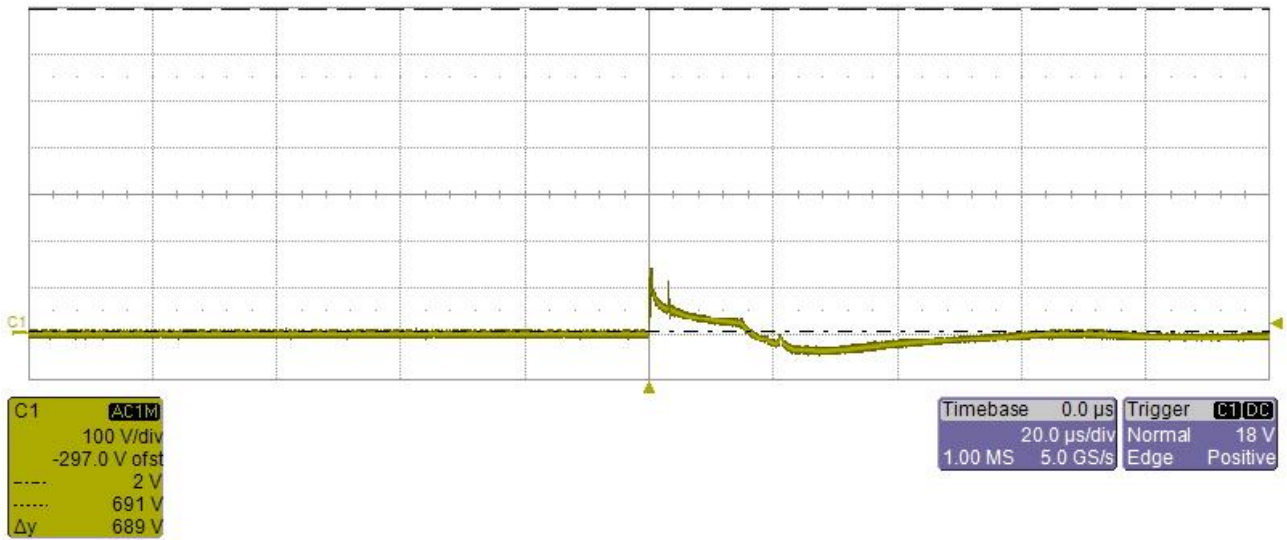
Diagram 11.8

| Photo | Diagram | Remark | Test Result |
|---|---|---|---|
| - | 11.8 | Measurement +600 V | pass |
